نتایج بررسی سانحه تصادم کشتی تانکر سانچی با کشتی فله بر کریستال سازمان بنادر و دریانوردی - اردیبهشت ۱۳۹۷

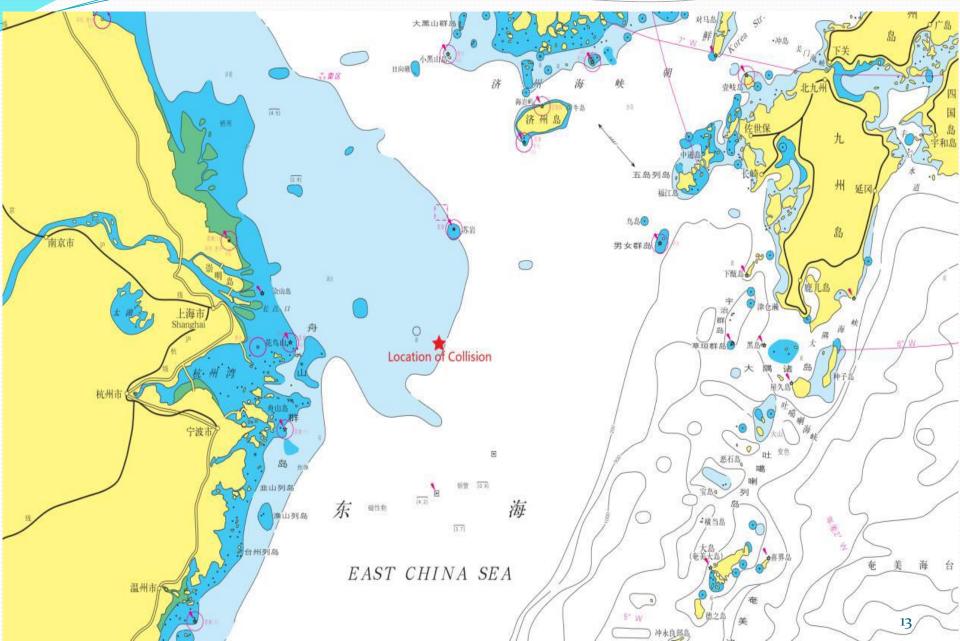
منطقه برخورد کشتی فله بر کریستال با تانکر سانچی

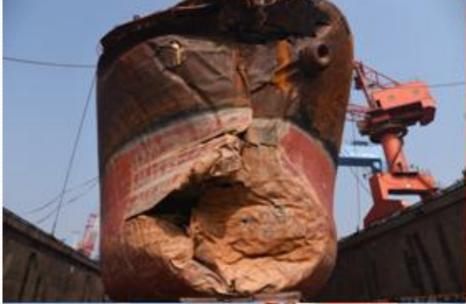
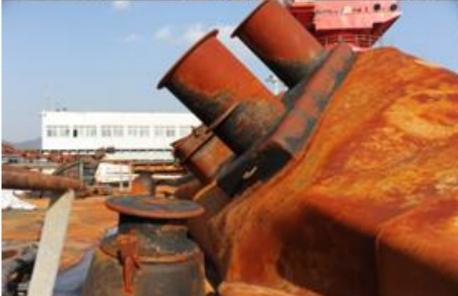
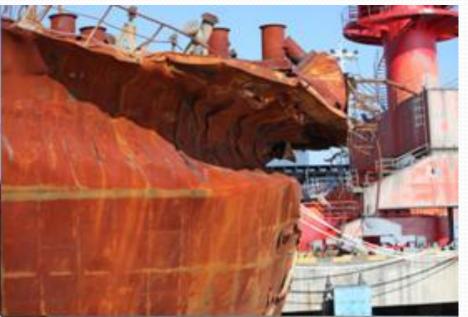
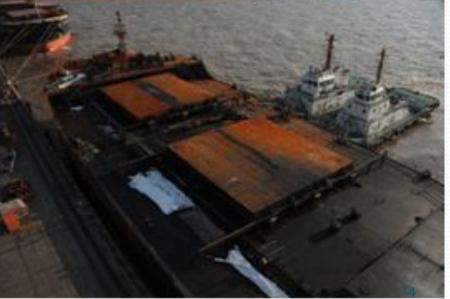
خسارات وارده به کشتی فله بر کریستال

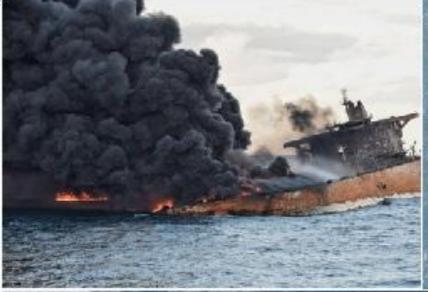
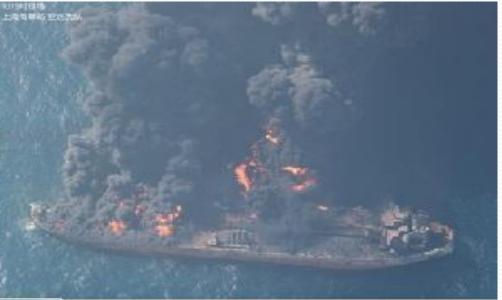
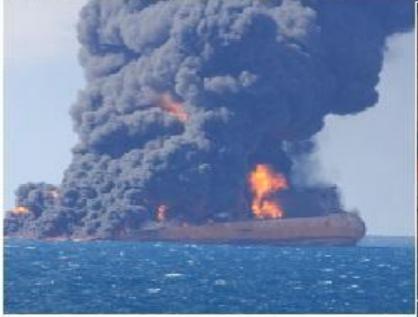
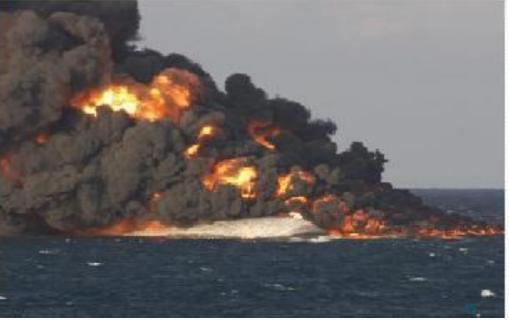
خسارات وارده به کشتی تانکر سانچی

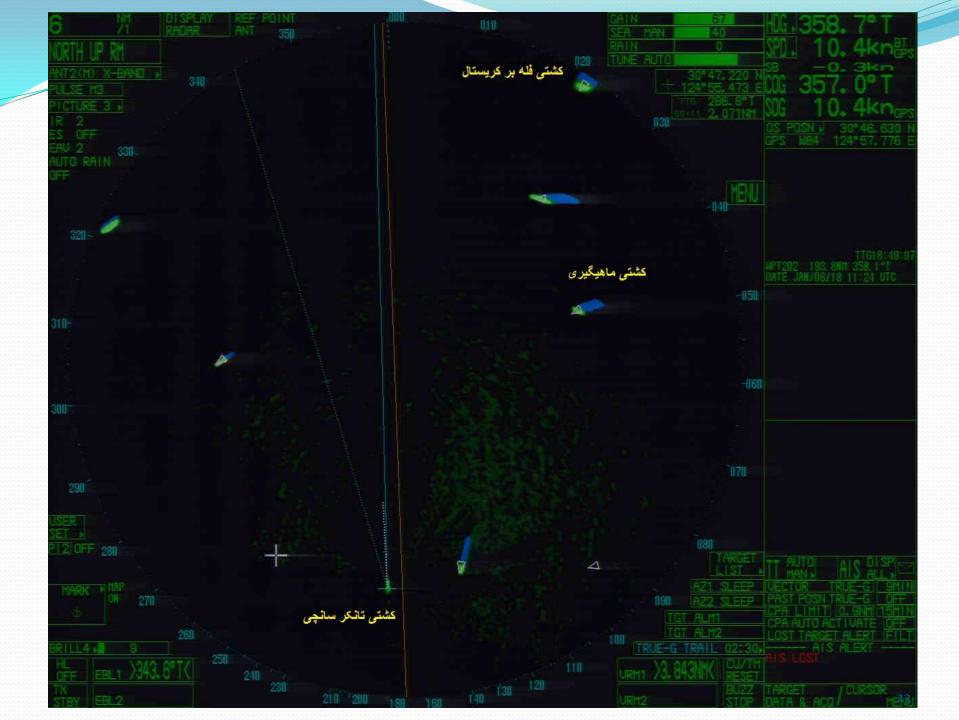
- Several vessels and boats crossing from starboard bow on Sanchi radar. CF Crystal first appears on radar screen (distance≈9.8 nm Speed=13.2 Co=214).
- Sanchi Speed: 10.4 knots
- Range scale RADAR in use 6 NM off center relative motion.

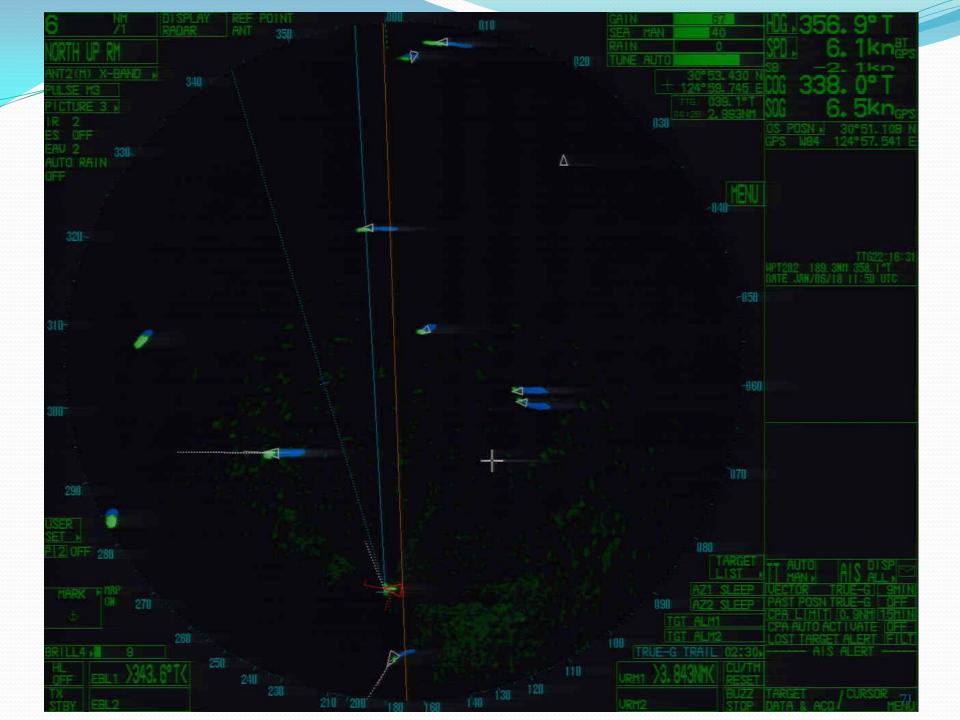
- Collision (LT19:50:03)
- Captain instruct to activate GMDSS

- Fire on board Sanchi. Captain instructs fire pumps starting.
- Fire on Bow Crystal
- Captain to the bridge and order for full stern.

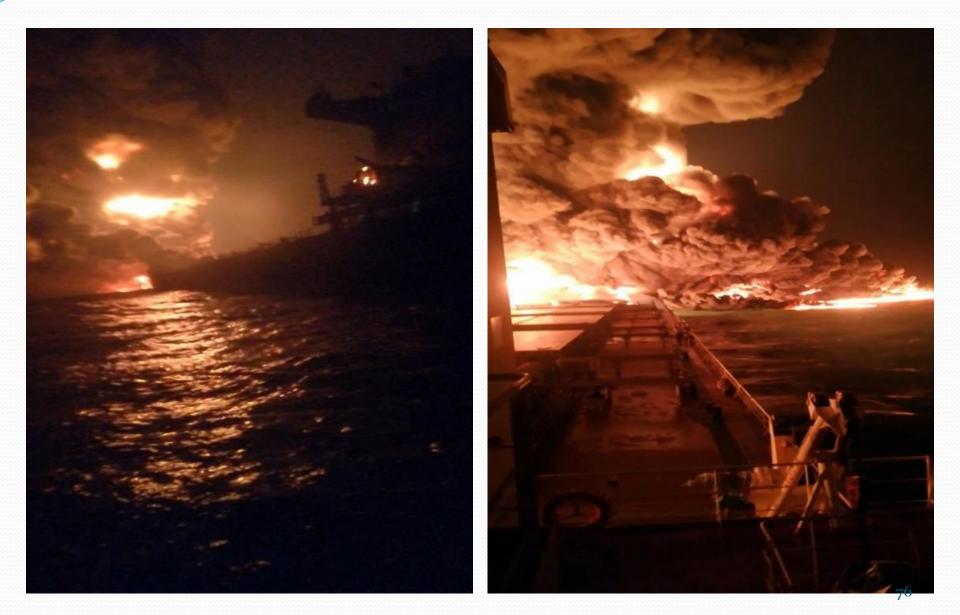
انفجار و حریق تانگر سانچی بلافاصله در زمان تصادم

Explosion and fire engulfing bridge & accommodation, followed by suffocation sounds.

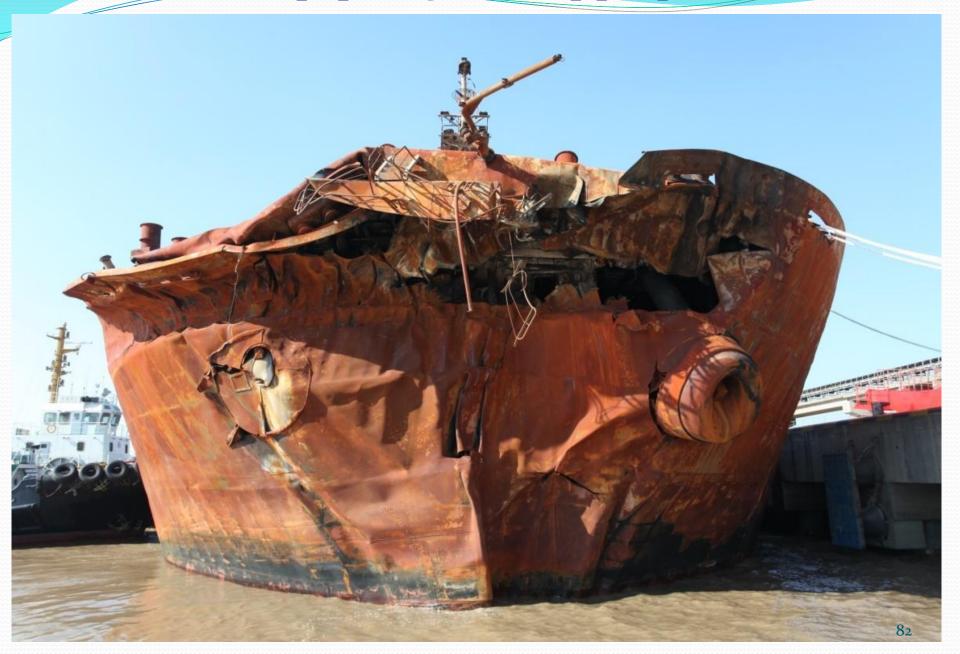
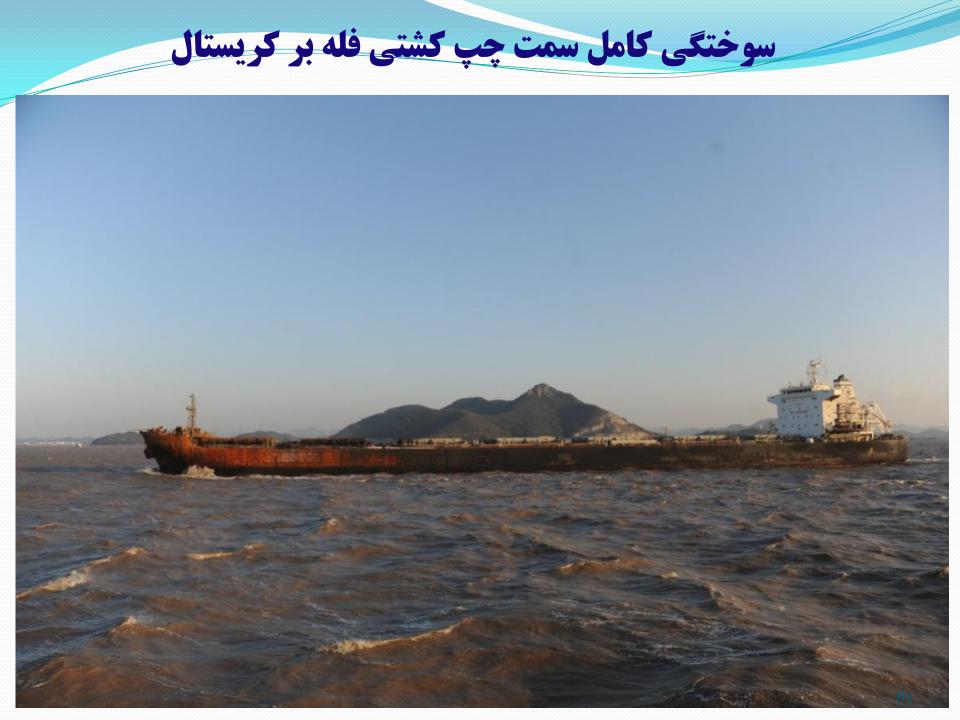
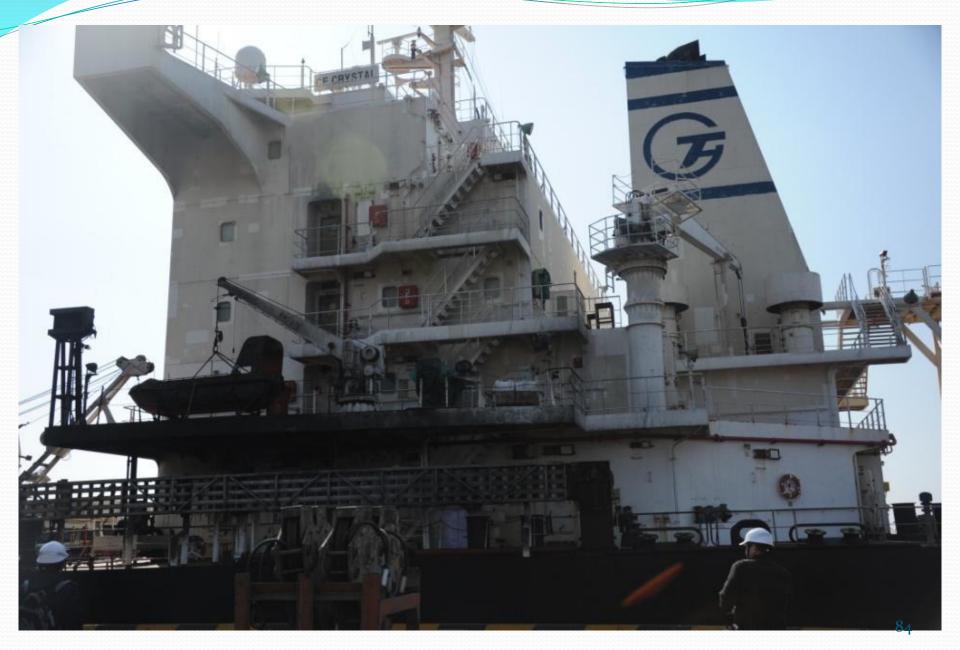
خسارات وارده به کشتی فله بر کریستال

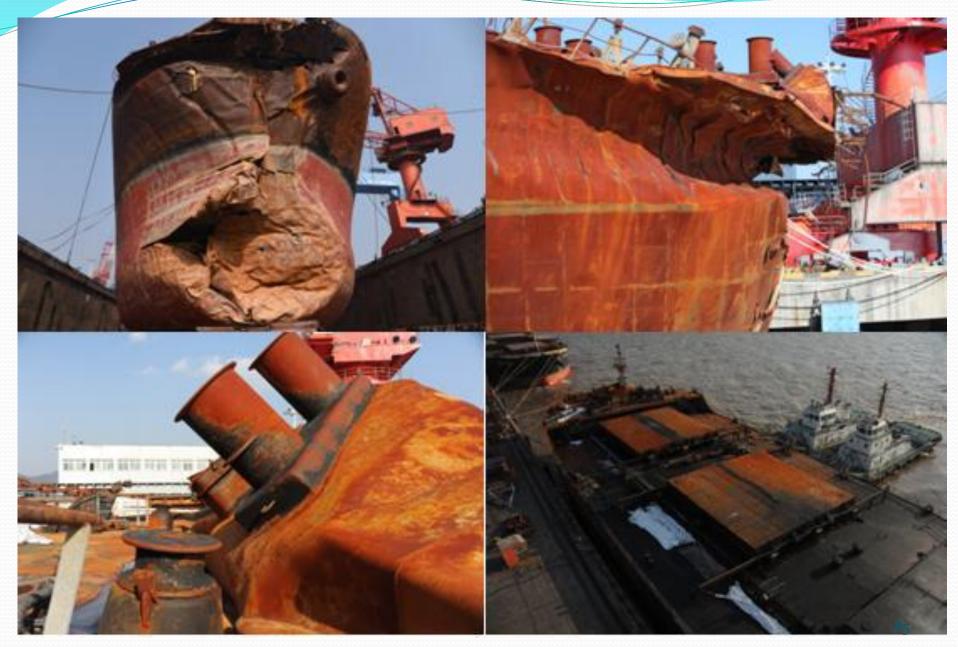
سوختگی تا انبار سوم و خسارت دماغه کشتی فله بر کریستال

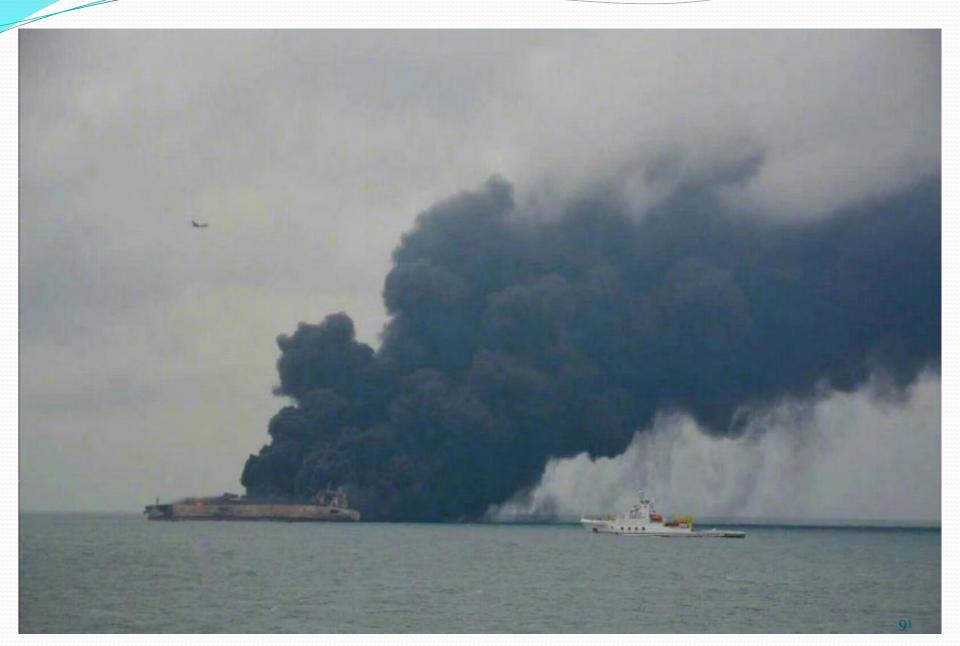
انفجارات مکرر در تانکر سانچی

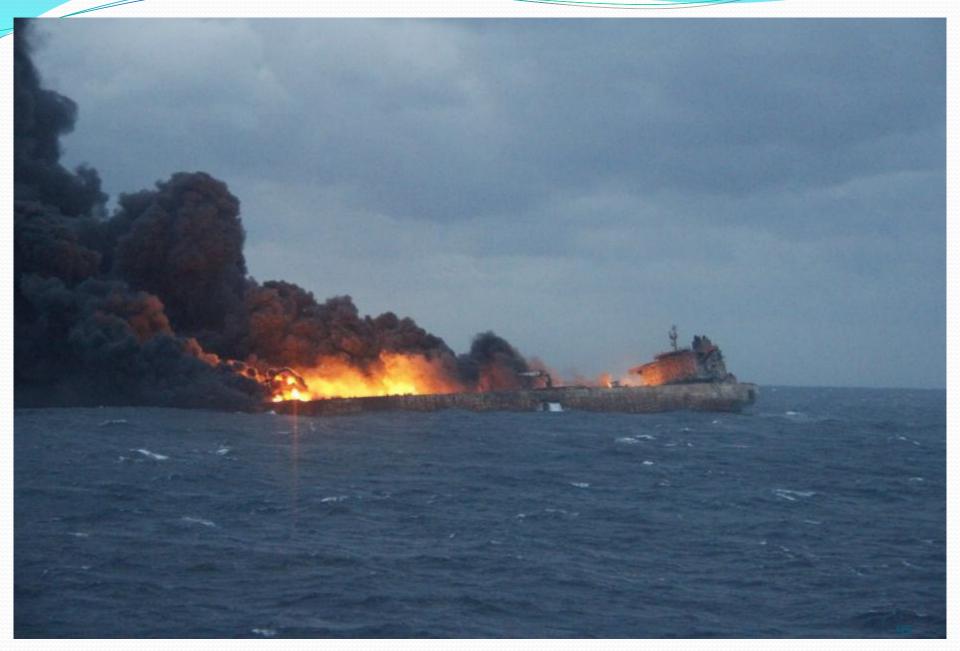
سرایت آتش به تمامی انبار ها و توسعه حریق سانچی
